Parking Scheme, Marden Road, Whitley Bay  
Road Safety Assessment  
North Tyneside Council

May 2012

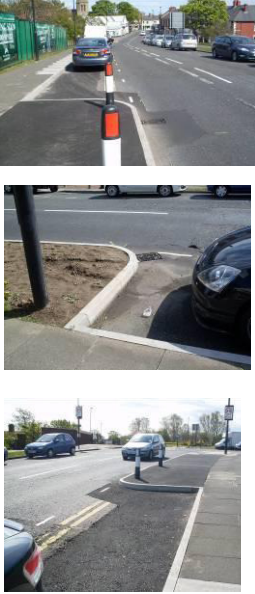
<p>4</p>	<p>Marden Road (both sides)</p>

<p>The parking bays have been constructed without a tapered entry/exit (virtually perpendicular to the main carriageway) with individual bays not marked out. This may lead to the following and subsequent conflicts:</p> <ul style="list-style-type: none"> <li>• Vehicles protruding into carriageway;</li> <li>• Sudden braking to enter parking area (particularly just after leaving roundabout); and</li> <li>• Several manoeuvres to enter/egress parking (including reversing and crossing into the opposing carriageway).</li> </ul> <p>In addition, there may be future maintenance issues in trying to sweep the bays and the removal of detritus leading to potential drainage issues.</p> <p>The lack of formal markings of the parking bays may also lead to reduced parking efficiency.</p>	<p>Provide either a kerbed or painted parking bay tapers.</p> <p>Mark out individual bays to ensure parking is controlled and formalised.</p> <p>This can be carried out following the resurfacing (programmed for 2 July 2012).</p>
